Hydrocarbon Fuel/Combustion- Chamber-Liner Materials Compatibility

Contract NAS 3-25070
Interim Final Report
NASA CR-185203
April 1990

Report No. KBQ-FR-1
NASA CR-185203

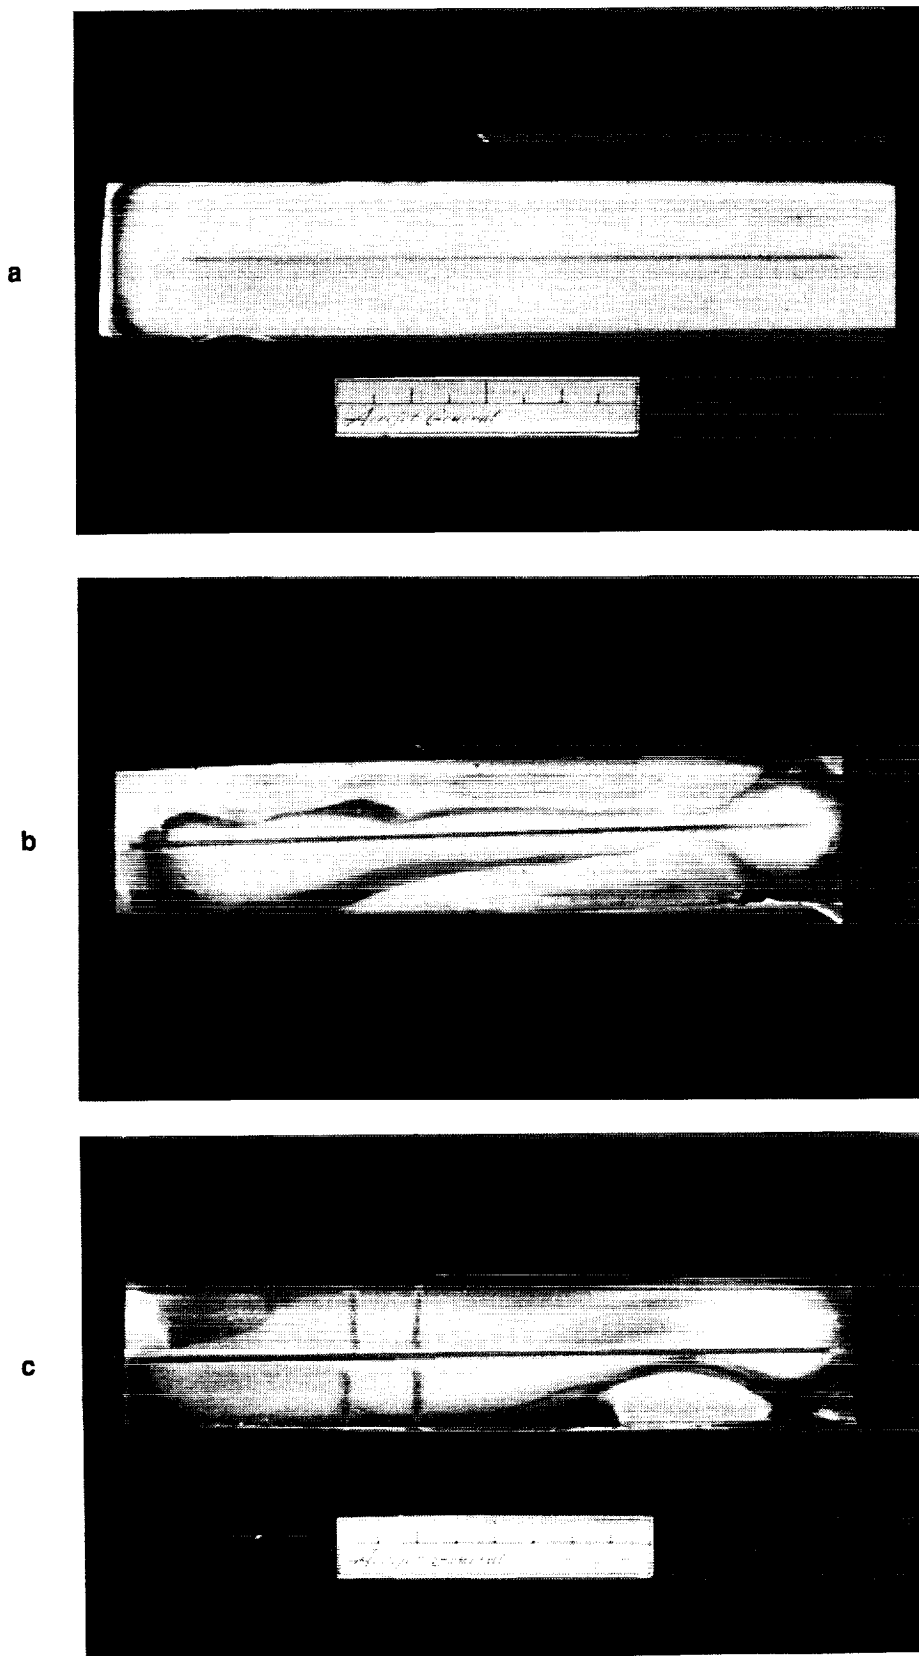
Figure 105. Disassembled Test Specimens Before and After Testing. a) Fabricated But Untested. b) Tested With 5 ppm Hydrogen Sulfide (Test M207). c) Tested With 10 ppm Hydrogen Sulfide (Test M208). Note: Transverse Marks on (c) and Guidelines for Sectioning

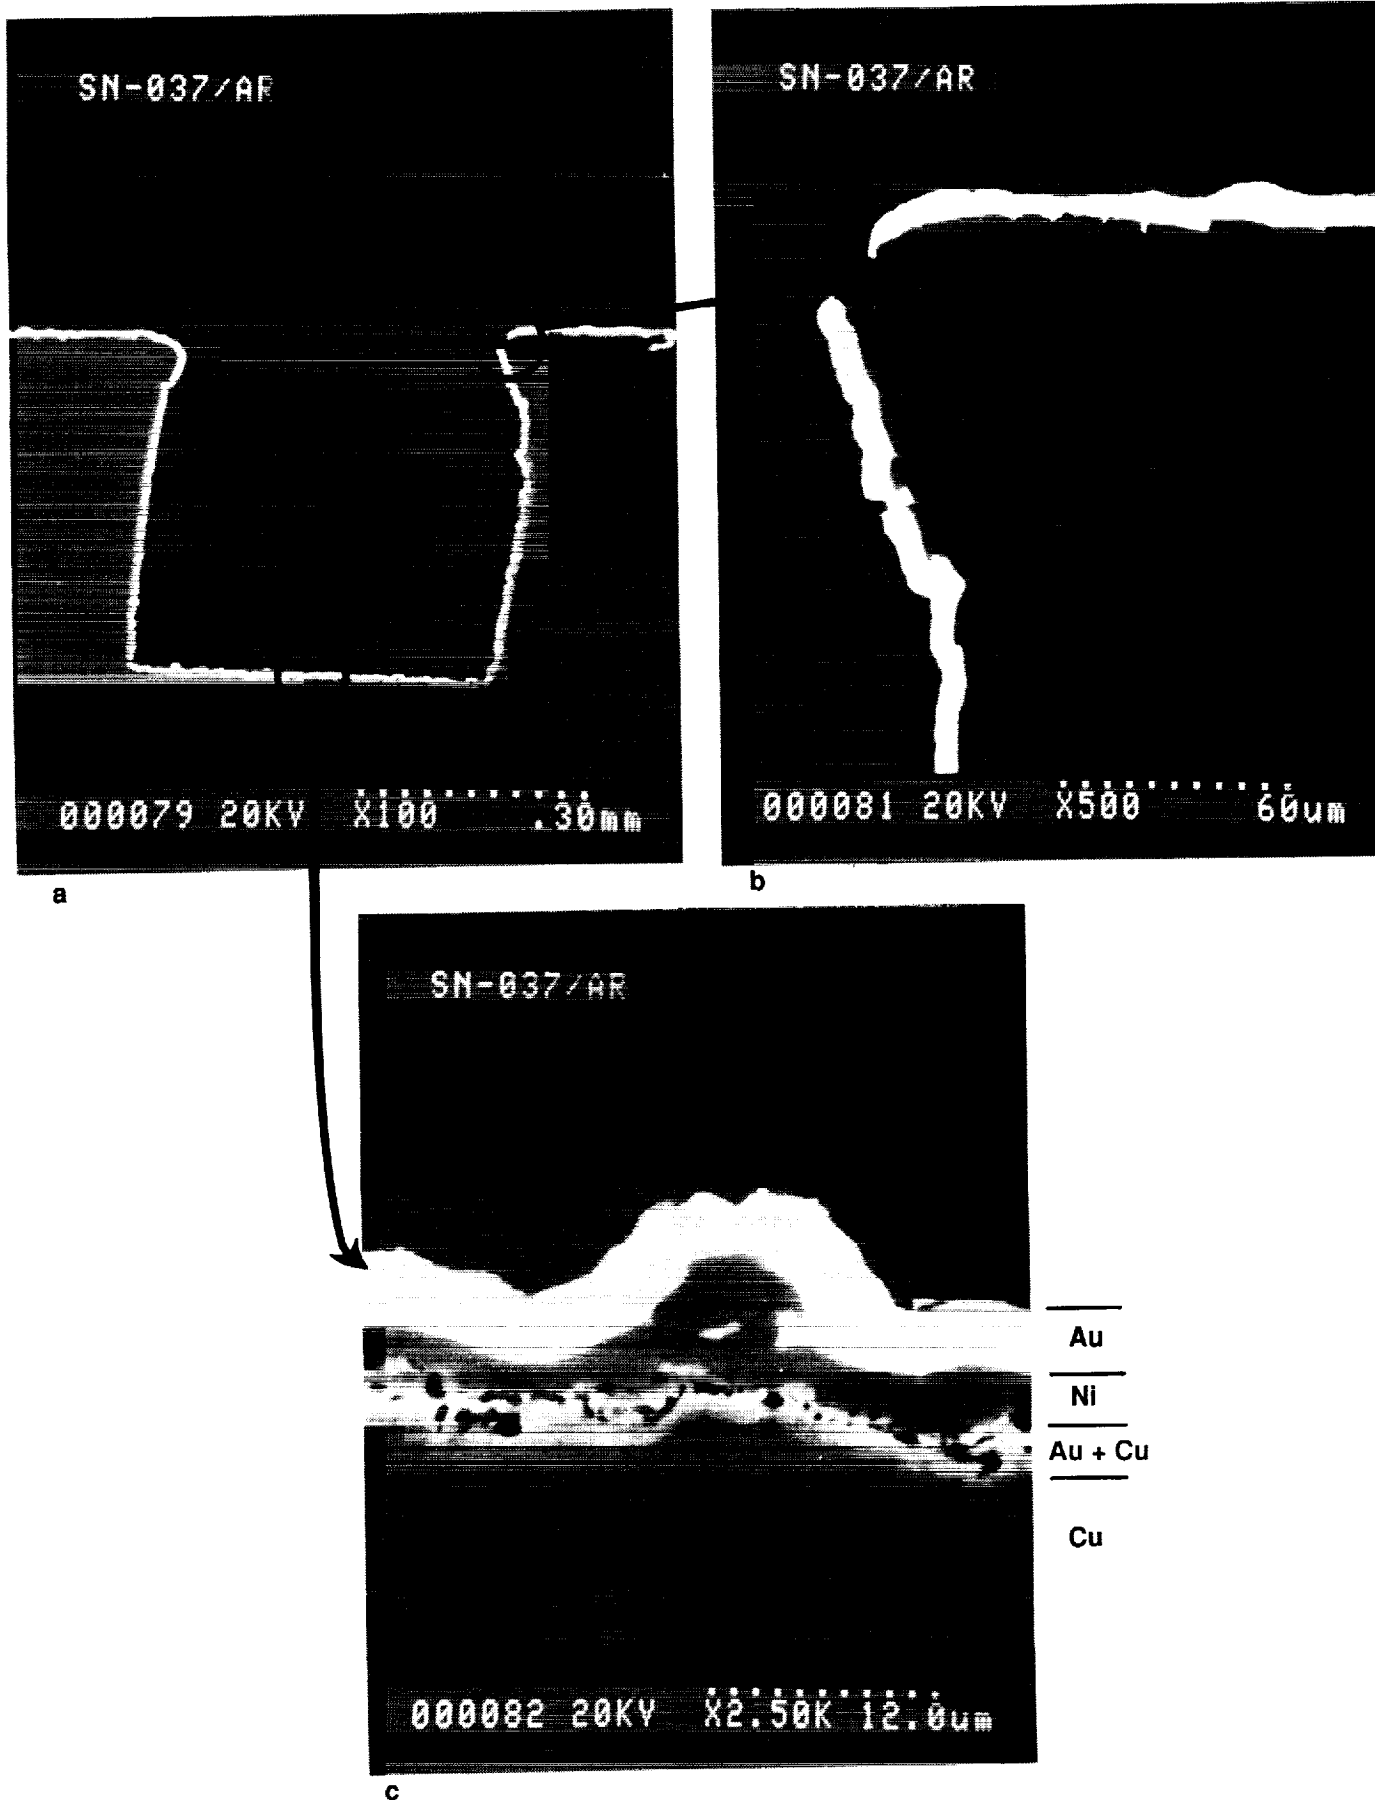
Figure 107. Cross Section of Untested Sample. Crack at the Top Corner Is a Result of Mechanical Damage During Specimen Fabrication or Disassembly

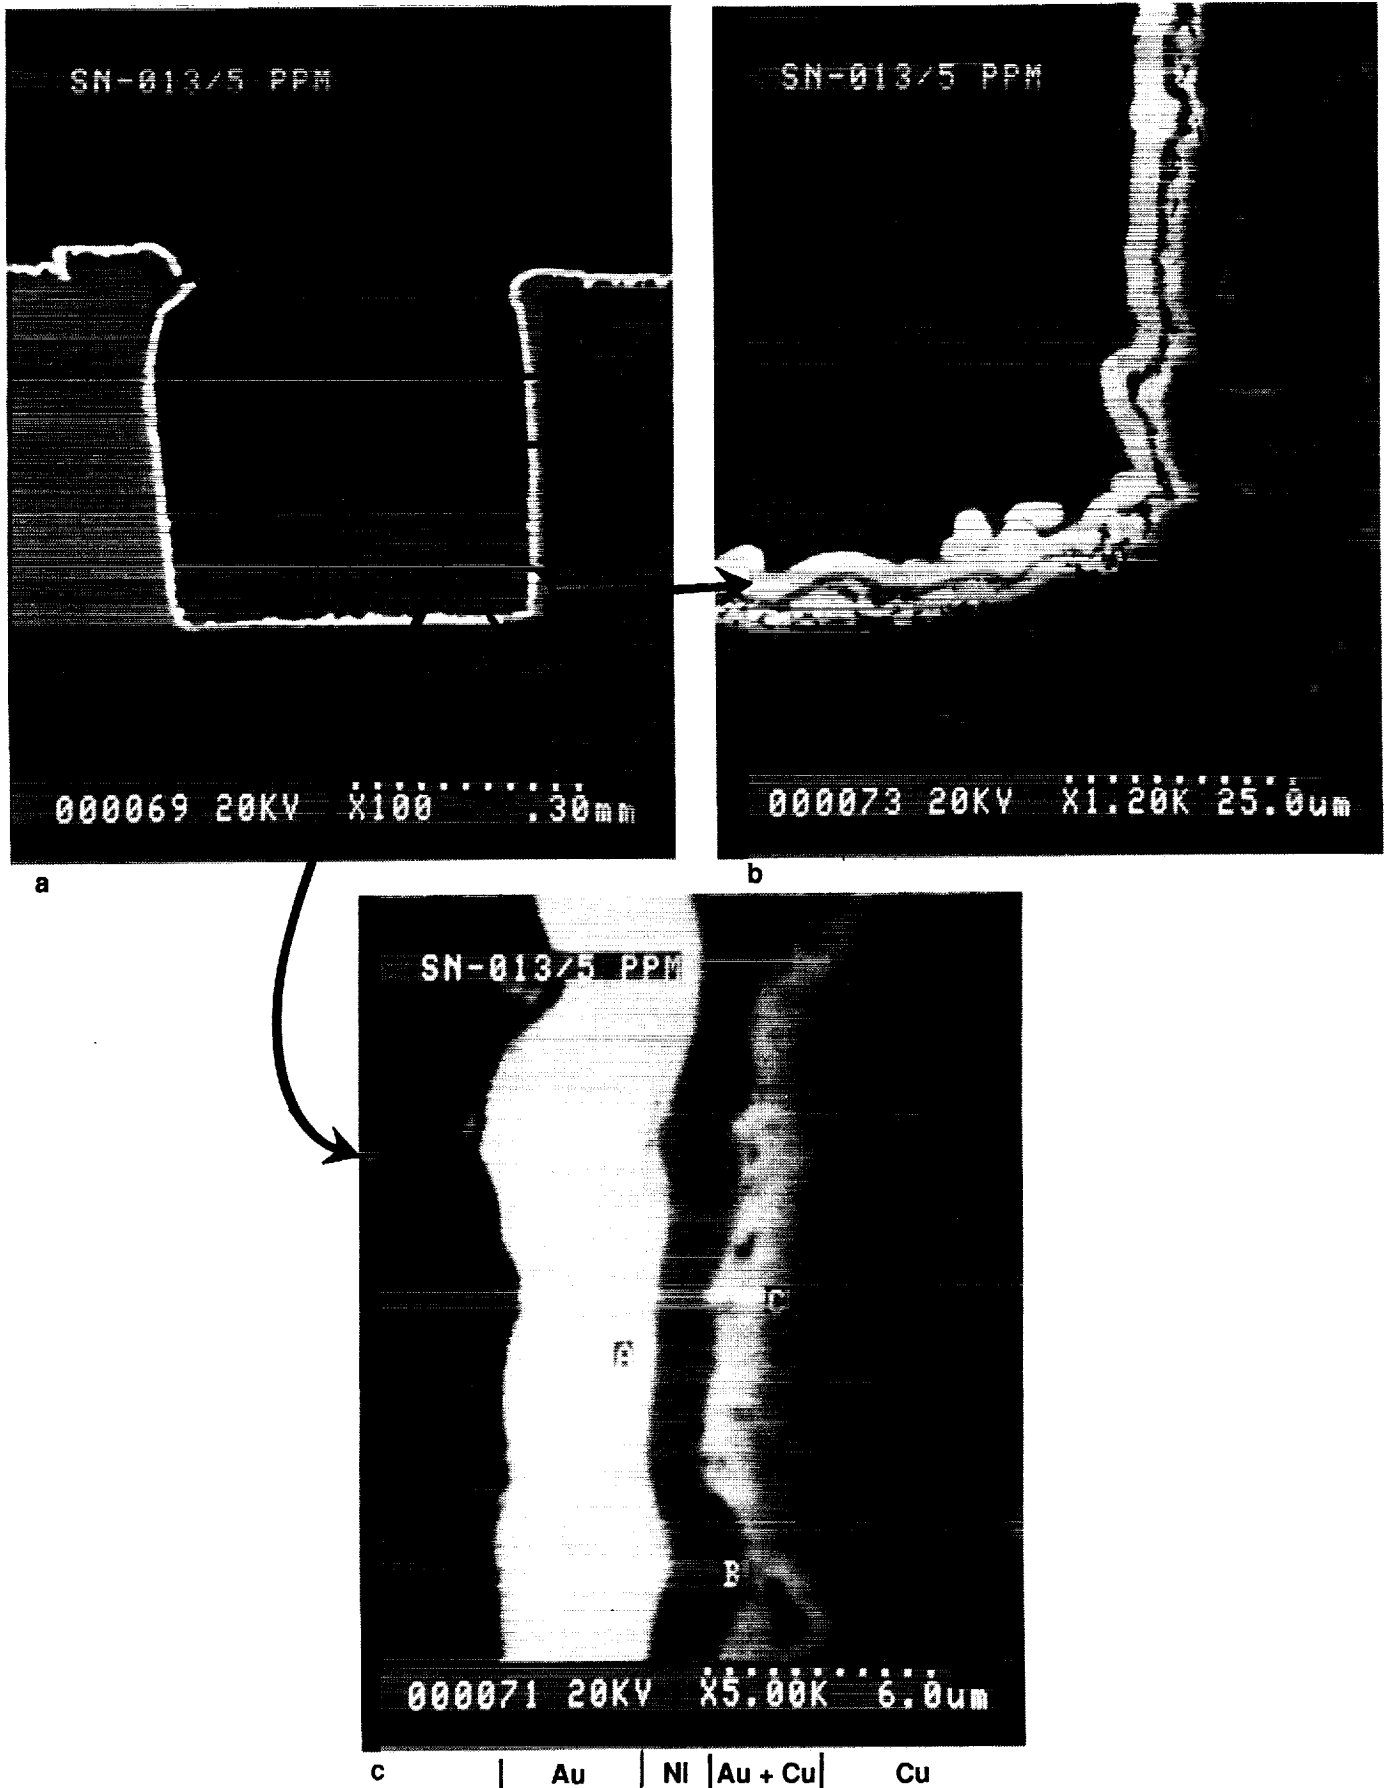
Figure 109. Cross Section of Sample After Test With 5 ppm Hydrogen Sulfide in Methane (M207)

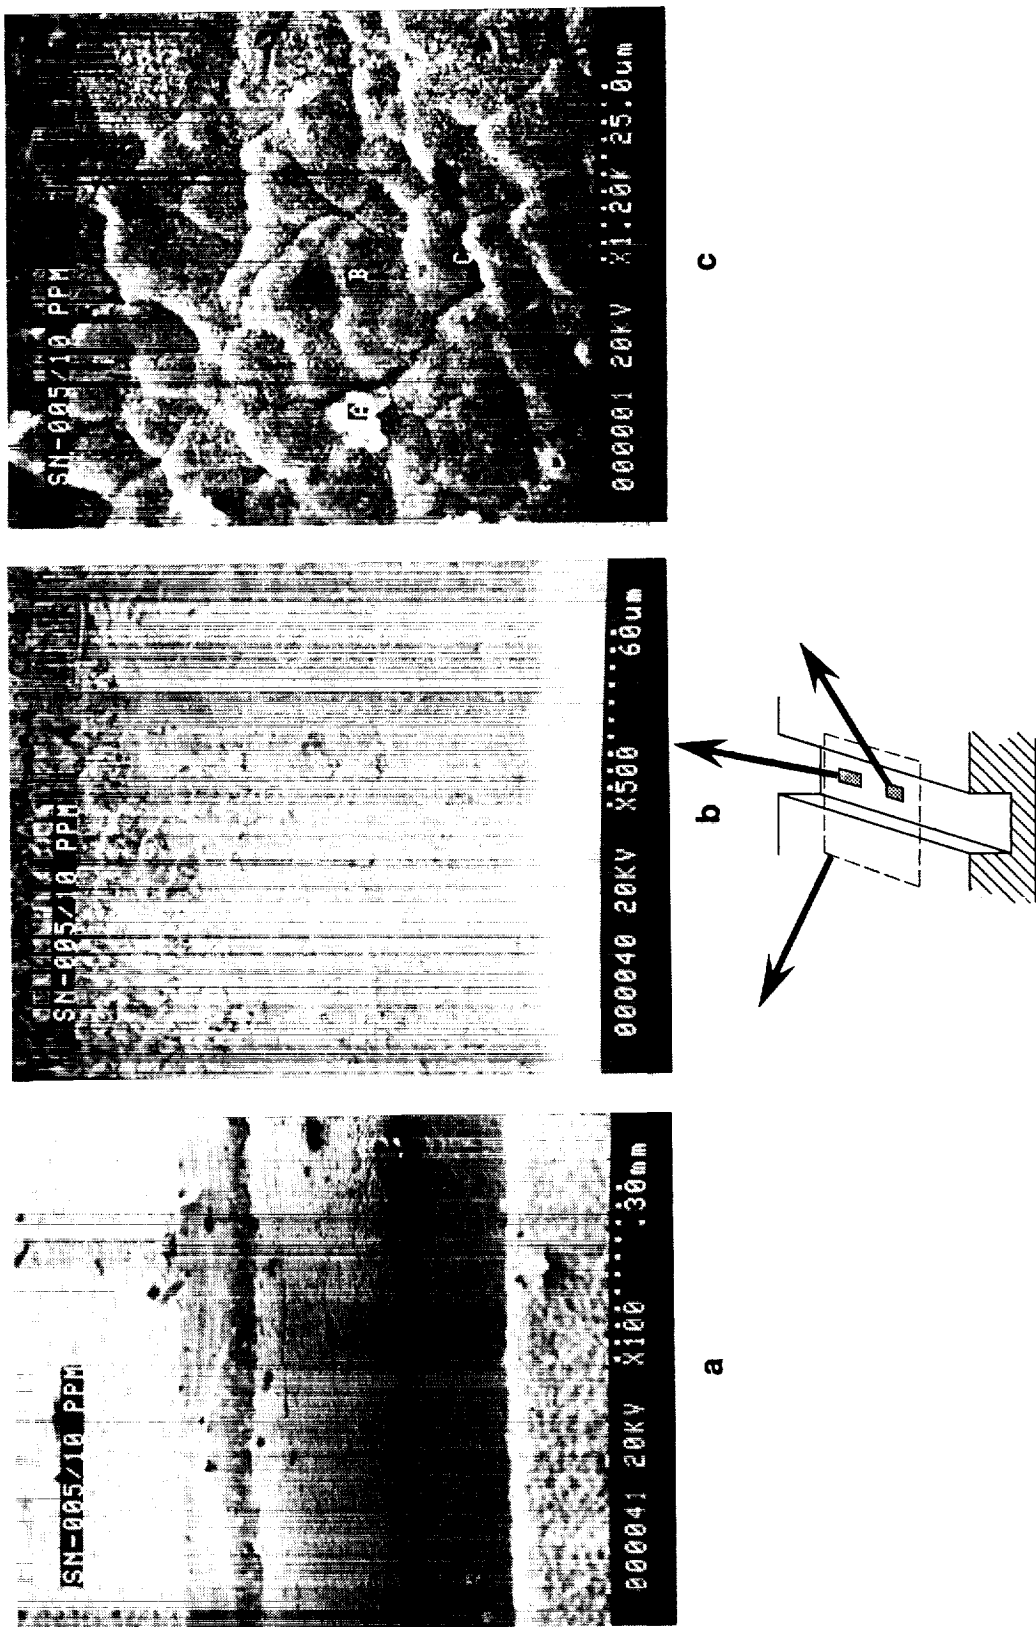
Figure 110. Looking Down at Channel Surface After Testing With Methane Plus 10 ppm H_2S (M208). Note That Channel Has Thin Covering of Sulfur "Fuzz"

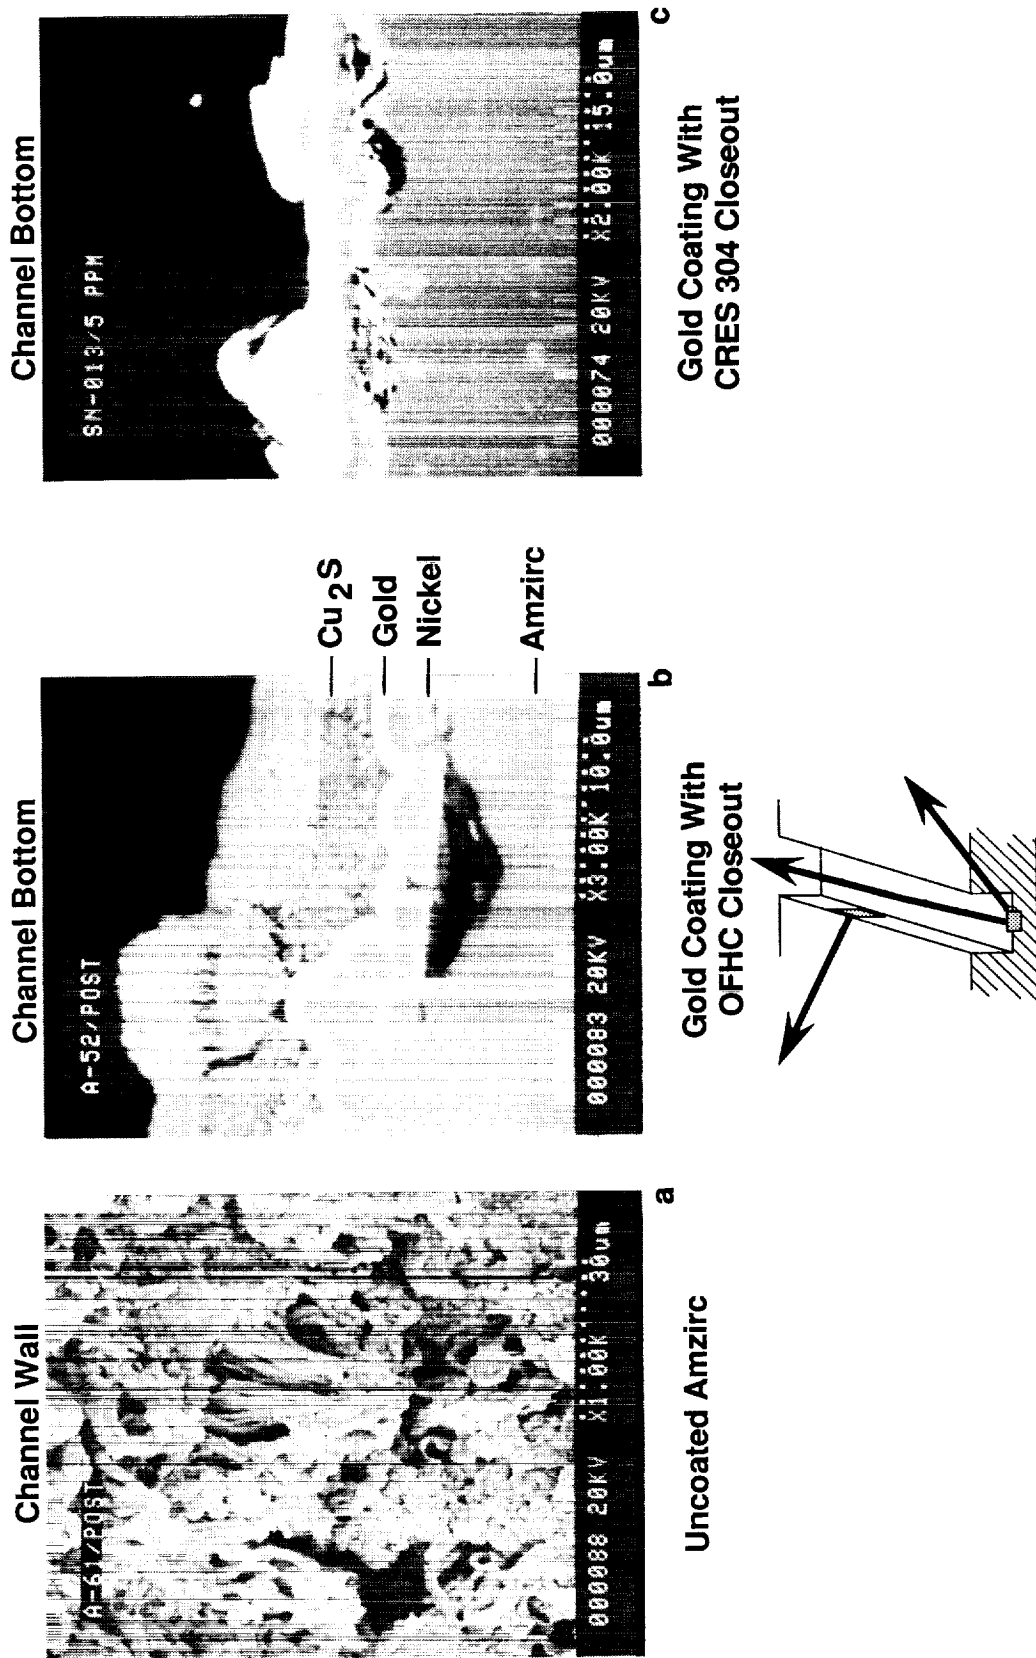
Figure 112. Post Test SEM Photos of Dynamic Test Specimen After Tests With Methane Plus 5 ppm H₂S
